Home Condition Report

Any Client
123 Elm Street, Kansas City, MO 64112

Inspected By: **Mike Blackman - Inspector**
Five Star Home Inspections, Inc.
913-219-8634

Inspection Date: **March 22, 2022**

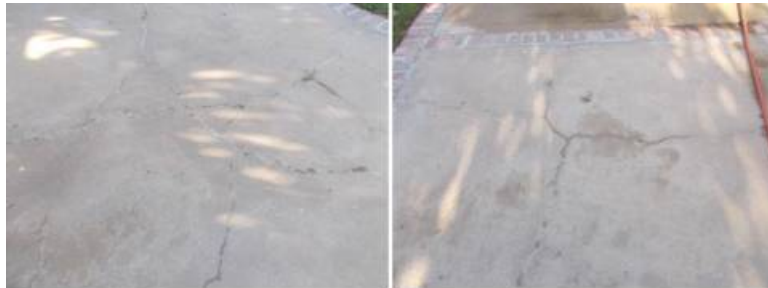
Driveway Condition:

Attention Needed - The driveway needs attention and repair to prevent further deterioration. The cracks in the driveway need to be sealed to prevent further damage. The freeze-thaw cycle may cause differential settlement and enlarge existing cracks.

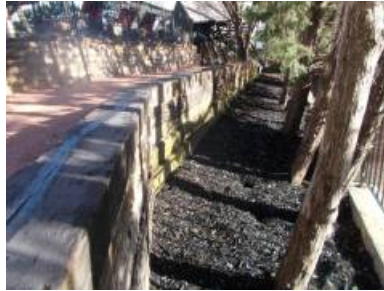
Condition of Wall and Materials Used:

Attention Needed - The retaining wall is in need of some repair in order to function properly. The east retaining wall adjacent to the pool has some movement and needs repair as needed by a professional landscape specialist.

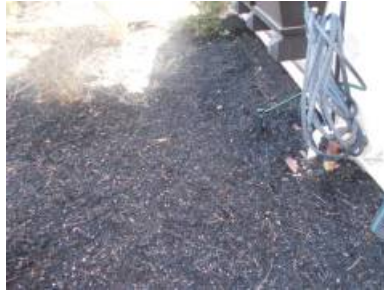
Perimeter Foundation Drainage Surface:

Attention Needed - The drainage around the foundation should slope away from the foundation at a rate of 1/2" per foot for 6' from the foundation. Portions of the ground around the perimeter do not meet this minimum standard and need additional dirt added or grading adjustment. Rear Wall.

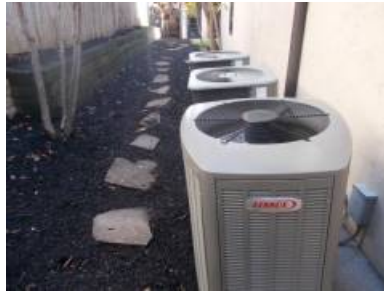
Condenser Cabinet Level:

Attention Needed - The condenser pad should be solid and within 5-10 degrees of level. If the tilt is over this figure, internal lubrication may be insufficient. It is recommended that the condenser and condenser pad are leveled. This is for all three condensers.

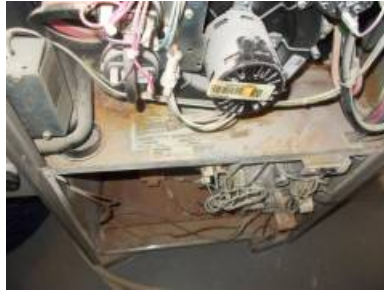
Furnace Cabinet Condition:

Attention Needed - The interior of the furnace cabinet shows signs of rust. Further investigation by a professional HVAC contractor is suggested to determine the cause and preventative steps needed. This is for the South furnace in the middle furnace room.

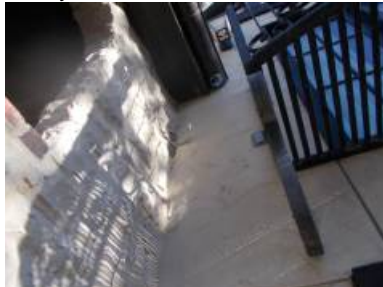
Roof Gutter System:

Attention Needed - There is a disconnected downspout at the front side of the home that needs to be reconnected for proper drainage away from the home. Also, the downspouts are connected to drain tile underground. I could not determine where the downspouts terminate or if they are clear.

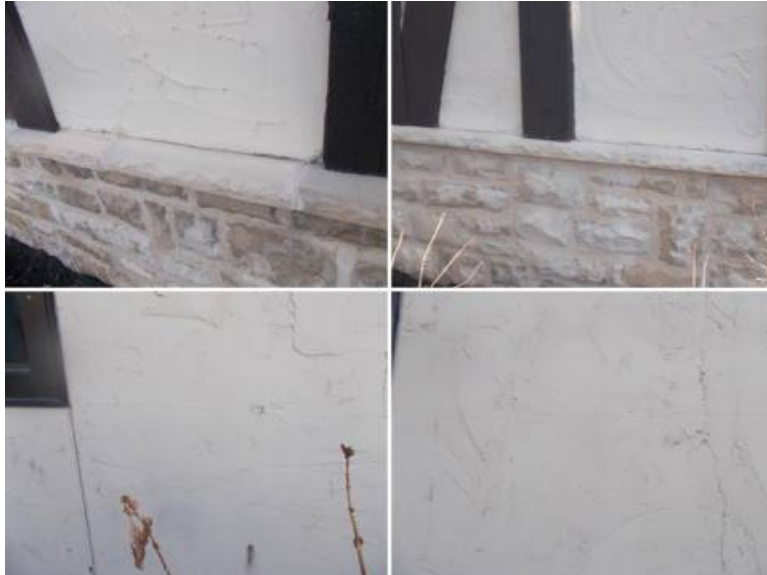
Siding Condition:

Attention Needed - The exterior siding material or finish is in a condition that requires repair to prevent further deterioration. There are some hair-line cracks in the stucco on the West side of the home that need to be sealed, and there is some deterioration in the stucco below the window outside the office. Also, there is no flashing installed at the stucco to stone trim transition on the front side of the home. It is recommended that either the transition has flashing installed or caulked on annual basis to prevent moisture behind the stone facade.

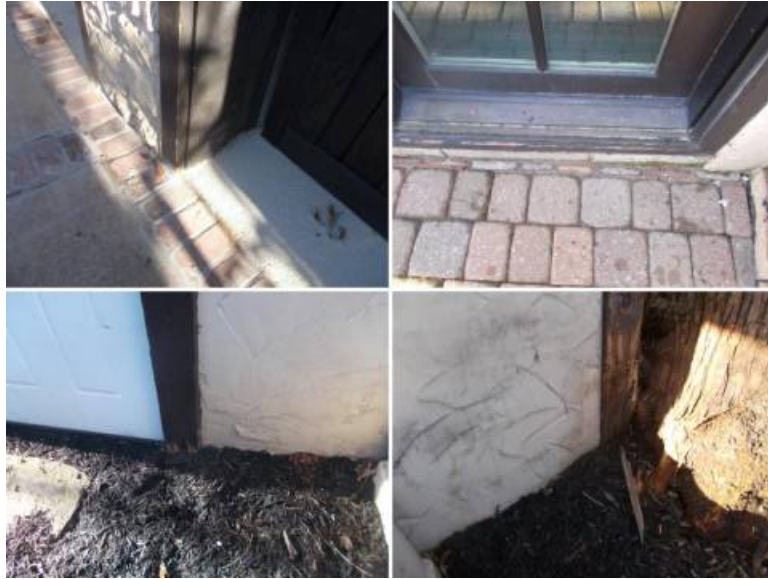
Trim Condition:

Attention Needed - The trim needs some repair to prevent further deterioration. There is trim deterioration in need of repair around the garage door, the rear exterior garage door, and around the shed.

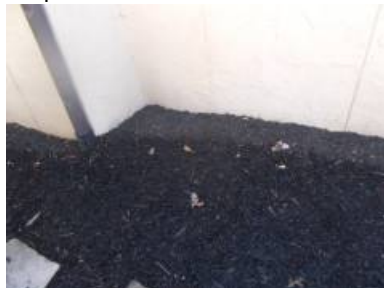
Earth to Wood Clearance:

Attention Needed - There does not appear to be adequate clearance between the earth and the wood siding or framing members of the structure. It is suggested that there should be a minimum 4" clearance between the earth and any wood siding or framing materials. This is for portions of the West and North sides of the home.

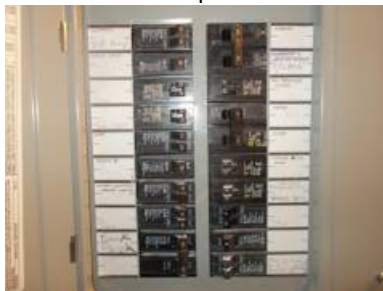
Condition of Wiring in Panel:

Action Necessary - There are non-matching breakers installed in the panel. The manufacturer obtains the UL rating using only the manufacturer-made breakers. It is recommended that a professional electrician evaluate the electrical panel and breakers and complete the necessary repairs so the breakers match the electrical panel. This is for the basement sub-panel. There are Square D breakers in an Eaton panel that need to be changed to Eaton breakers.

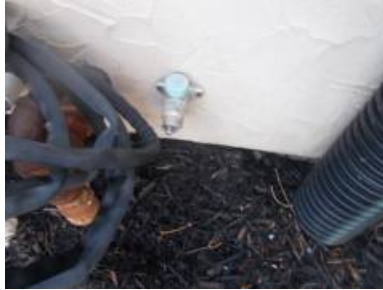
Exterior Hose Bibs Functional:

Attention Needed - The rear exterior hose bib is missing the handle. The handle needs to be replaced so it can be tested for function. Satisfactory - The exterior hose bib(s) appeared to function normally.

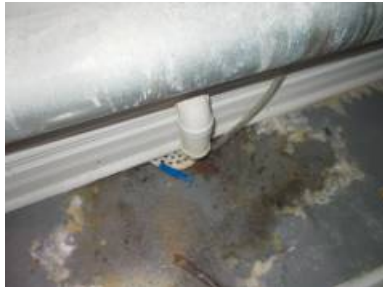
Waste Piping Condition:

Attention Needed - Some portion of the visible plumbing waste piping needs attention. There is an open pipe that is leaking above the floor drain in the double furnace room that needs to be repaired. I could not determine what the drain pipe is for or where it is coming from.

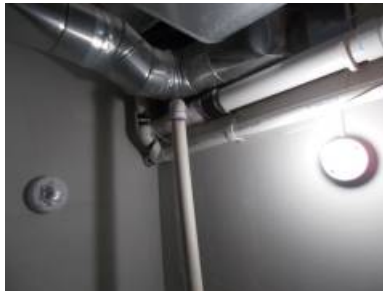
Sump Pump Drain Line:

Action Necessary - The sump pumps empty into the public sewage system. This practice is not allowed. It should be rerouted to the exterior or to a dry well.

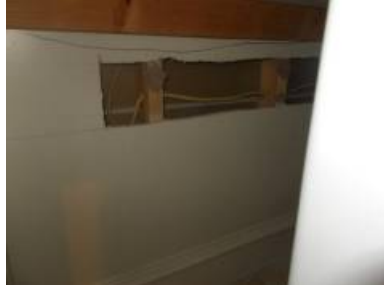
Walls:

Attention Needed - The walls in the laundry show a condition that needs some attention. There is a hole in the drywall around the laundry area that needs repair.

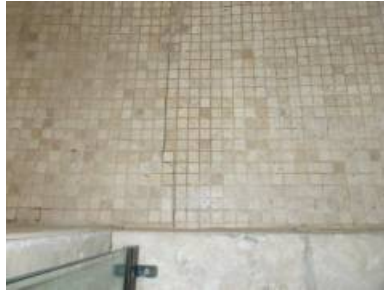
Shower Pan:

Action Necessary - The tile in the upper level master bathroom is cracked. It is recommended that a professional plumber evaluate the tile and shower pan and complete any necessary repairs to prevent future leakage.

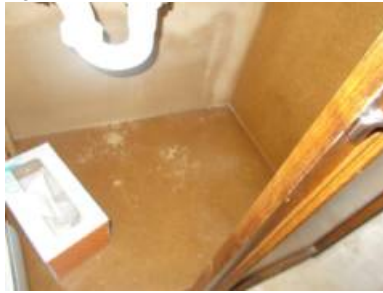
Basin and Drain Fixtures:

Attention Needed - The basin or drainage fixture needs attention. There is a leak in the drain line that needs to be repaired. This is located below the right sink in the main level master bathroom.

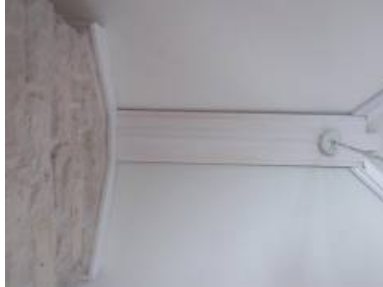
Ceiling:

Attention Needed - There is a condition in the ceiling that needs to have attention. There is evidence of an unrepaired stain on the wall caused by a prior moisture leak. This is for the upper office ceiling.
